DeepRetr0fit Assessment and interventions on a typical 1970's weatherboard home

DeepRetr0fit Consultation

Date

June 2022

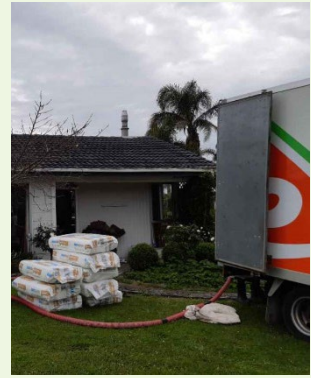
Before: Gaps in insulation around lights (dark colour = heat loss)

Before: No wall insulation (dark colour = heat loss)

- ✓ The owner has had the recessed light fittings replaced with energy saving LED fittings
- ✓ New fittings are rated IC, meaning they can be covered with insulation - less gaps!
- ✓ Owner progressively replacing other inefficient bulbs throughout the house with LED bulbs

- ✓ The SupaWall blow-in insulation system provides a convenient, keyhole solution
- ✓ Insulation installation was completed in a day, with the remedial work completed immediately
- ✓ Less waste and cost when compared to removing the plasterboard linings
- ✓ High performance R2.8 solution which meets or exceeds the recent Building Code insulation update

- ✓ Insulation installed around and over the new recessed LED light fittings
- ✓ Internal dropdown ceiling walls insulated
